| Make: | Land Rover | Model: | Range Rover |
| Body Style: | Wagon | Year: | 2009 |
| Good No.: | 28419326 | VIN: | SALLSAA238A188596 |

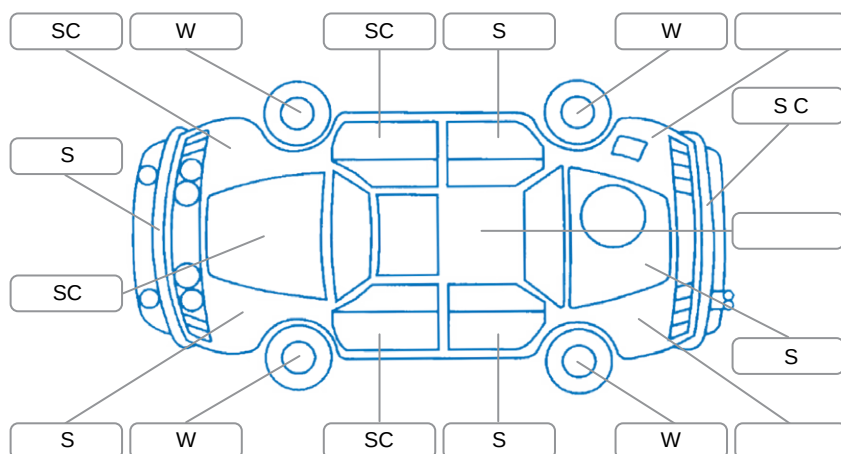
S = Scratch    R = Rust    C = Crack    \* = Decals    W = Significant scuffs  
D = Dent    PT = Paint defect    P = Pin dent    SC = Stone Chips

Note: some defects and blemishes may not be displayed in the diagram

### Minor stonechips on windscreen
