| Report ID: | 28,421,417 | Version: | 2 |

| Make: | Volkswagen | Model: | T6 |
| Body Style: | Van | Year: | 2018 |

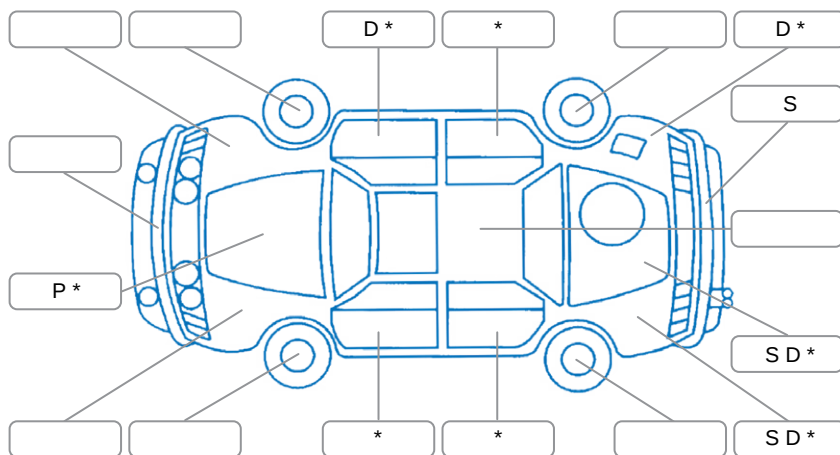
S = Scratch R = Rust C = Crack \* = Decals W = Significant scuffs  
D = Dent PT = Paint defect P = Pin dent SC = Stone Chips

Note: some defects and blemishes may not be displayed in the diagram

Both taillights cracked, high stop light cracked, rear wiper blade worn, left rear reflector cracked, rear wiper blade plastic cover missing, left tail gate strut missing, engine oil leak, left sliding door refit.
