| Report ID: | 28,425,855 | Version: | 1 |

| Make: | Mercedes-Benz | Model: | Vito |
| Body Style: | Van | Year: | 2015 |

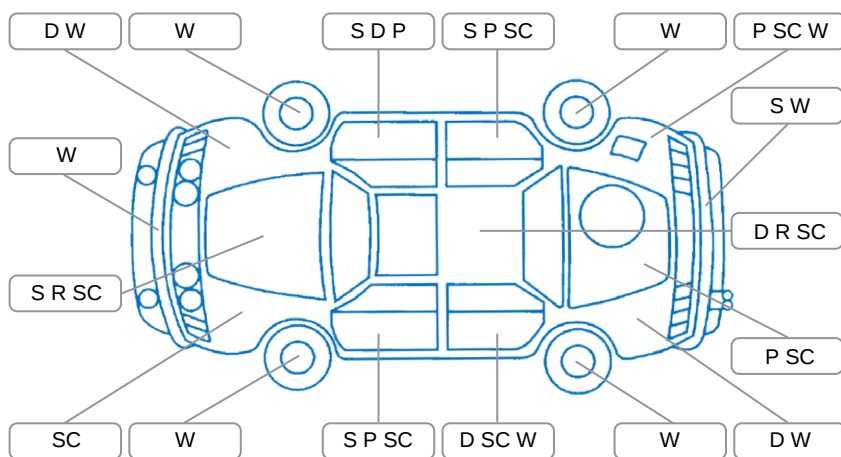
S = Scratch R = Rust C = Crack \* = Decals W = Significant scuffs  
D = Dent PT = Paint defect P = Pin dent SC = Stone Chips

Note: some defects and blemishes may not be displayed in the diagram

Moisture in R/F tail light  
R/F wing mirror damaged, R/R tail light cracked, L/R tail light has hairline cracks.  
L/R quarter mould missing, L/R door handle damaged.  
Windscreen crack/chip inside & outside of cva.
