| Report ID: | 28,525,225 | Version: | 1 |

| Make: | Mazda | Model: | Atenza |
| Body Style: | Wagon | Year: | 2005 |
| Rego No.: | FTK524 | Rego Expiry: | 31 Jul 2027 |

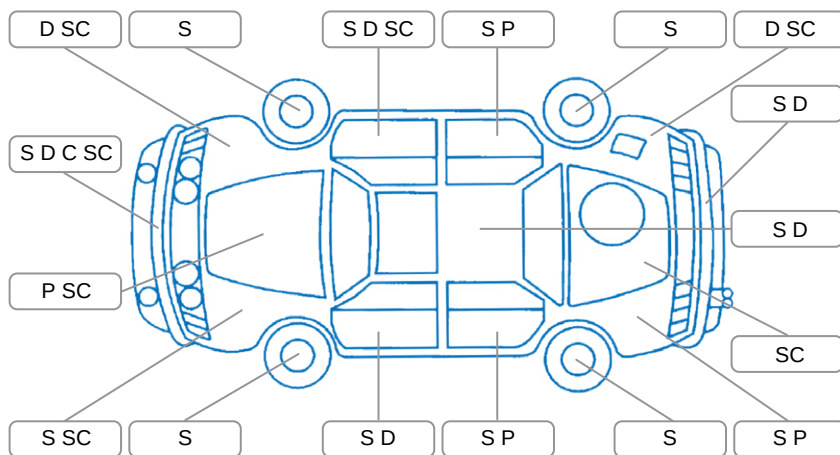
Note: some defects and blemishes may not be displayed in the diagram

Front grill broken and needs refit  
Front left wheel arch missing.  
Left sill dented.
