Basic Vehicle Condition Guide

Report ID: 17,797,514
Version: 3
Created: 30 Apr 2019

Make:	Mitsubishi	**Model:**	Triton	**Body Style:**	Utility
Year:	2012	**Registration:**	GJM4	**Reg Expiry:**	01 Jul 2019
WoF Expiry:	06 Jul 2019	**Odometer:**	125,617 Kms	**Good No:**	17797514
VIN:	MMAJNKA40CD0063C	**Next Service:**	127,500kms	**Service History:**	Yes

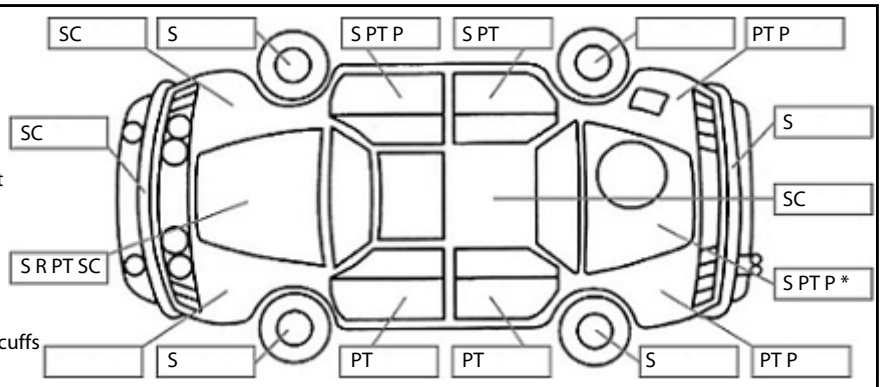
- Small stone crack in left side of windscreen.
- Screw holes on inside lips of right & left side front guards, where aerials have been attached to vehicle.
- Badge missing off rear tailgate.
- Paintwork on most body panels is marked & faded, from where stickers have been attached to vehicle.
