# Turners

## Basic Vehicle Condition Guide

Report ID: 17,964,102
Version: 2
Created: 12 Feb 2019

| **Make:** | Ford | **Model:** | Territory | **Body Style:** SUV |

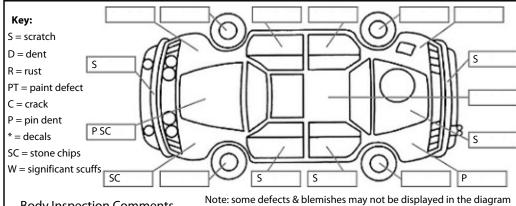
Diagram labels: S, S, P SC, S, SC, S, S, P

### Body Inspection Comments
Stone chip on front windscreen
RH tail lamp chipped
