# Turners

# Basic Vehicle Condition Guide

Report ID: 18,893,851
Version: 1
Created: 13 Feb 2019

| **Make:** Mazda | **Model:** Mazda3 | **Body Style:** Sedan | |

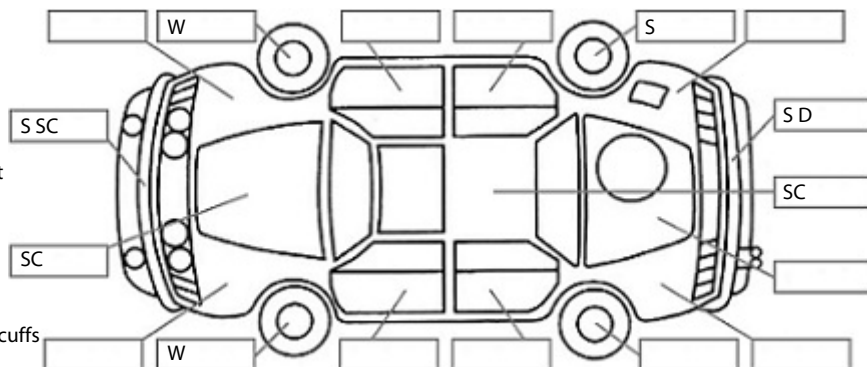
Diagram labels: W, S, S SC, S D, SC, SC, SC, W, W

## Body Inspection Comments
RH tail light lens cracked
