# Turners

## Basic Vehicle Condition Guide

| **Make:** BMW | **Model:** 3 Series | **Body Style:** Sedan |
| **Year:** 2007 | **Registration:** HHQ872 | **Reg Expiry:** 12 Sep 2019 |

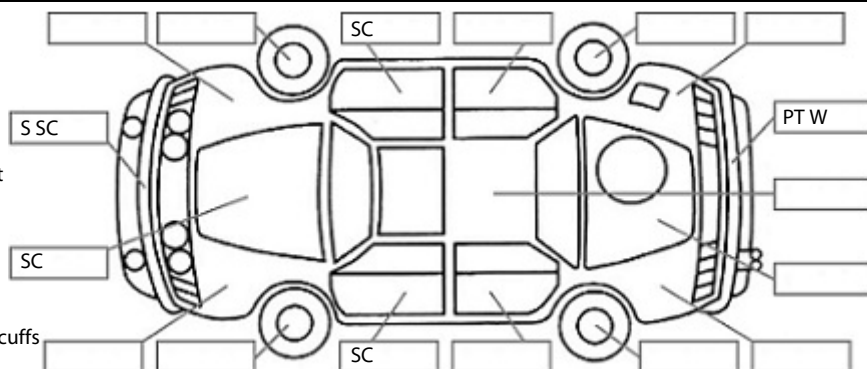
Diagram markings: SC, S SC, SC, SC, PT W

### Body Inspection Comments
has dent in r/r piller
