# Basic Vehicle Condition Guide

Report ID: 19,163,659
Version: 1
Created: 26 Apr 2019

| **Make:** | Peugeot | **Model:** | 407 | **Body Style:** | Sedan |
| **Year:** | 2008 | **Registration:** | EUM104 | **Reg Expiry:** | 13 Jul 2019 |

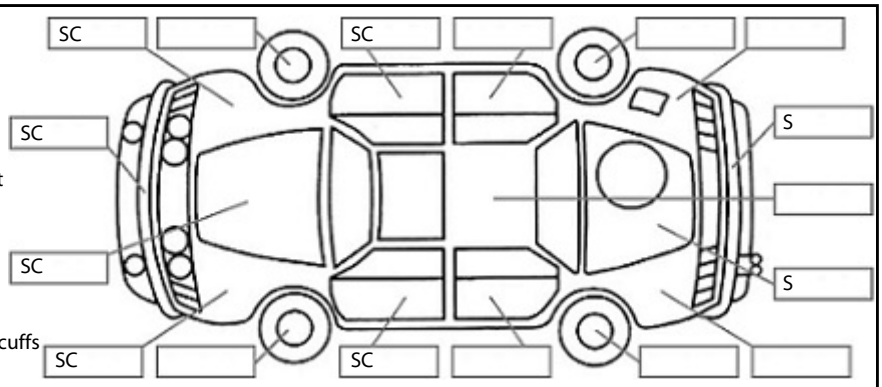
.

Conditions During Body Inspection: Dry
