# Basic Vehicle Condition Guide

| **Make:** | Toyota | **Model:** | Caldina | **Body Style:** | SUV |
| **Year:** | 2004 | **Registration:** | FHA917 | **Reg Expiry:** | 10 Nov 2019 |

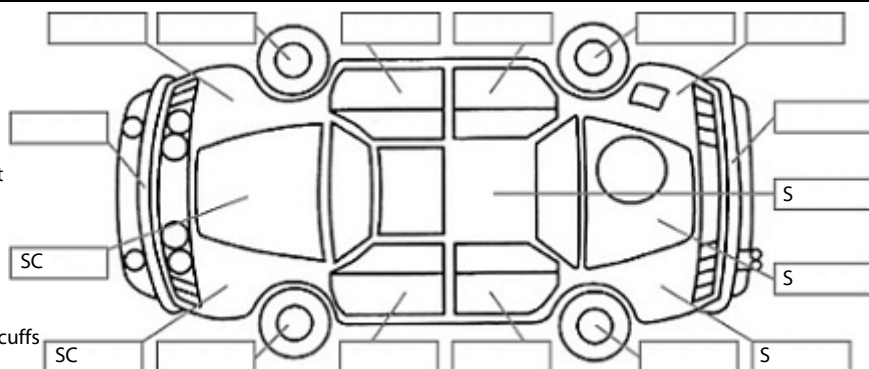
Diagram labels: S, S, S, SC, SC

Note: some defects & blemishes may not be displayed in the diagram
