Basic Vehicle Condition Guide

Report ID: 19,477,260
Version: 1
Created: 09 May 2019

Make:	Opel	**Model:**	Vectra GL	**Body Style:**	Sedan
Year:	1992	**Registration:**	PS2808	**Reg Expiry:**	10 Aug 2019
WoF Expiry:	21 Sep 2019	**Odometer:**	288,032 Kms	**Good No:**	19477260
VIN:		**Next Service:**	N/A	**Service History:**	No

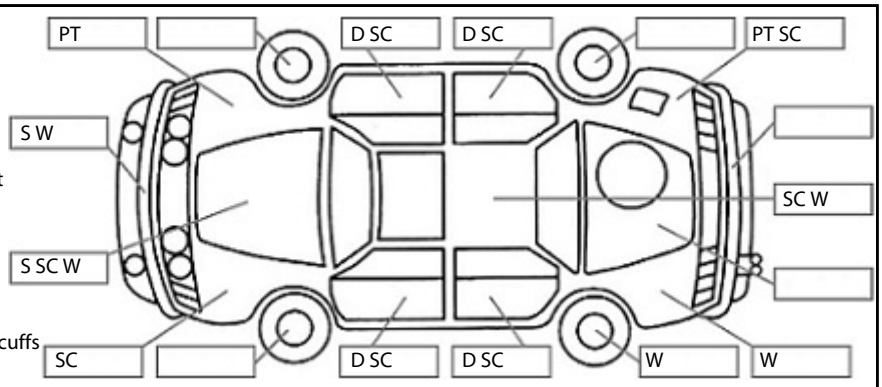
Note: some defects & blemishes may not be displayed in the diagram

Left wing mirror is broken. Rear bumper needs refitted. Right front cv boot torn.
