# Turners

## Basic Vehicle Condition Guide

Report ID: 19,810,030
Version: 1
Created: 08 Oct 2019

| **Make:** | Mazda | **Model:** | CX-5 | **Body Style:** | SUV |

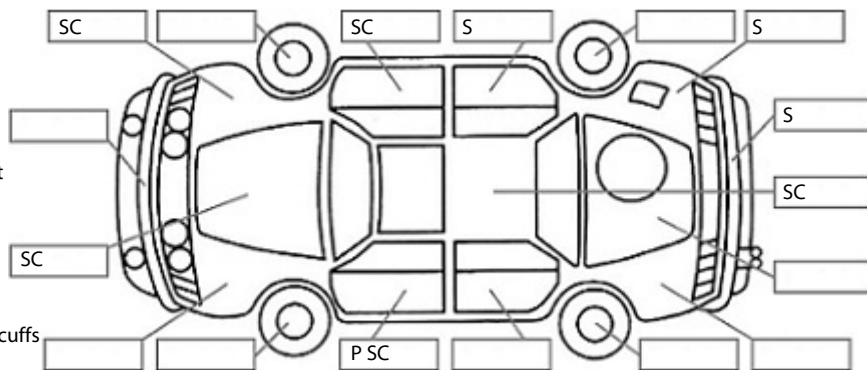
Diagram labels: SC, SC, S, S, S, SC, SC, SC, P SC

### Body Inspection Comments
FL park light/DRL not working, flickers
