# Turners

## Basic Condition Guide

| Make: | Subaru | Model: | Solterra |
| Body Style: | Wagon | Year: | 2024 |

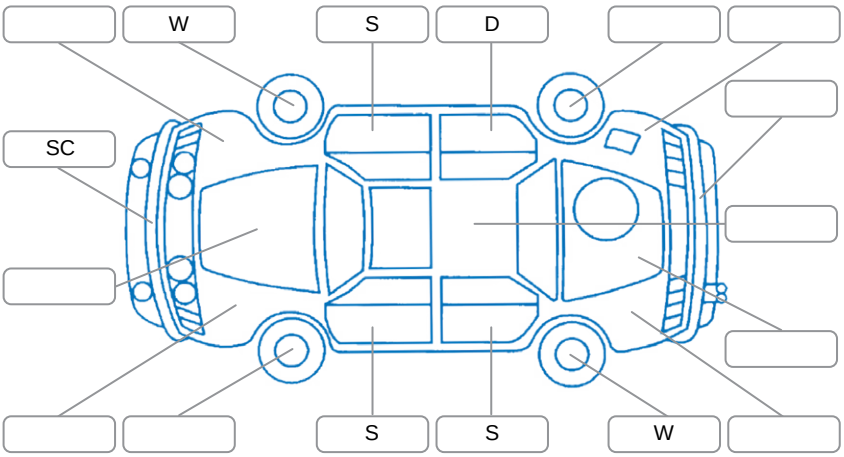
Spare wheel tools missing .roof gutter moulding front both side mis.
Home charger only.
