Turners

Basic Condition Guide

Report ID:	24,880,015	Version:	2
Created:	08 Oct 2026

Make:	Hyundai	Model:	Iload
Body Style:	Van	Year:	2015
Rego No.:	HYB979	Rego Expiry:	13 Oct 2027
WoF Expiry:	21 May 2027	Odometer:	319,863 Kms
Good No.:	24880015	VIN:	KMFWBX7KLEU653429
Next Service:	323,000,km's	Service History:	Yes

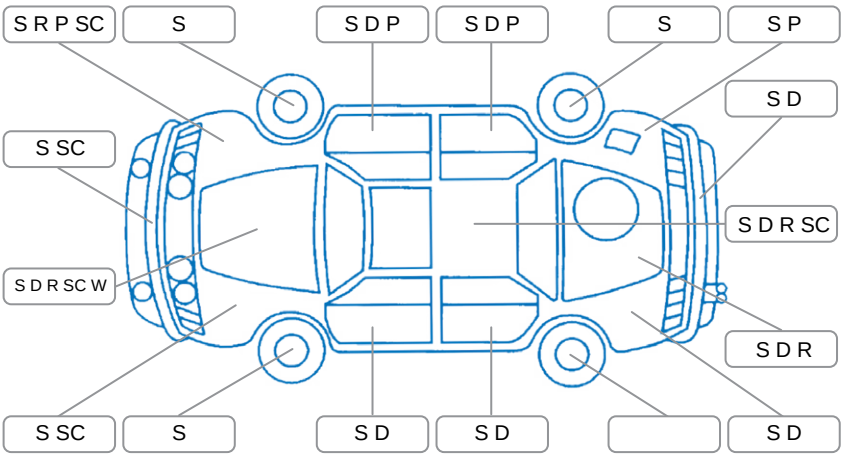
S = Scratch R = Rust C = Crack * = Decals W = Significant scuffs
D = Dent PT = Paint defect P = Pin dent SC = Stone Chips

Left & right side windscreen mouldings are missing. Roof rack need refitted down, roof rails has pull out of roof panel. Water inside indicator repeater lens on left front guard.
