# Turners

## Basic Condition Guide

| Make: | Toyota | Model: | Hilux |
| Body Style: | Utility | Year: | 2012 |

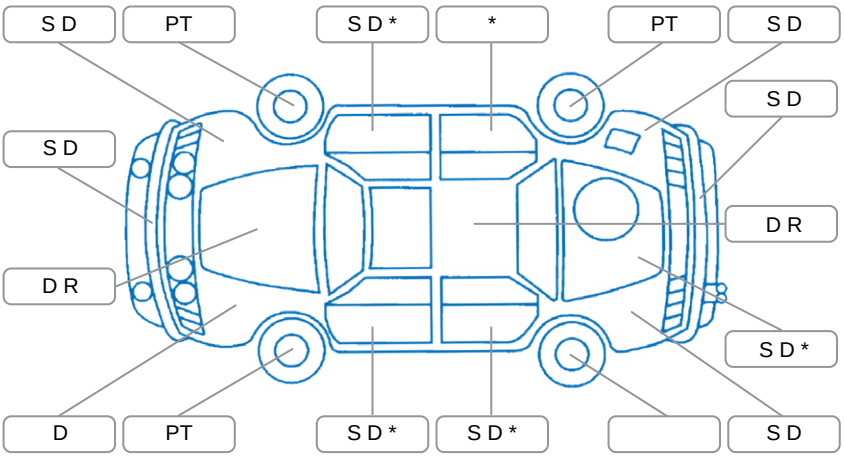
R brake light cracked, front bumper badge missing, engine oil leak from rocker cover gasket, underbody rust, both front wheel play, front brake rotor low,
