## Basic Condition Guide

| Make: | Isuzu | Model: | D-MAX |
| Body Style: | Utility | Year: | 2016 |
| Rego No.: | JZZ113 | Rego Expiry: | 21 Aug 2027 |

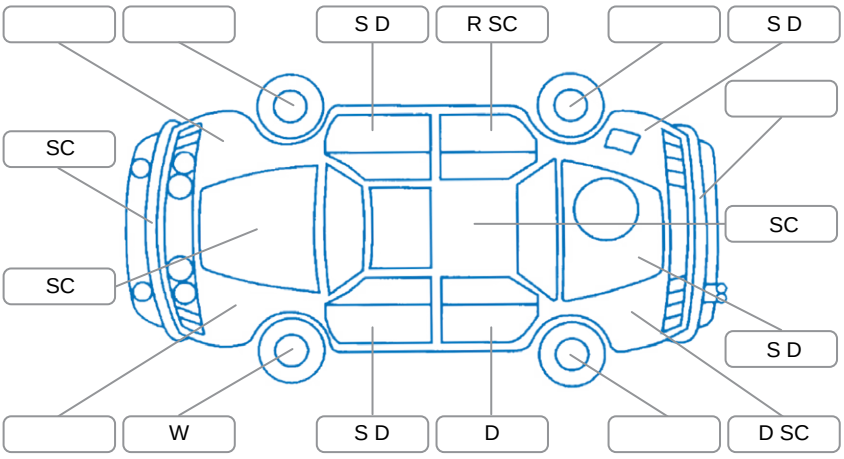
Rear console cup holder crack. Windscreen crack.
Front both head lamp faded. Air vent cracked,
