# Turners

## Basic Condition Guide

| Make: | Subaru | Model: | Levorg |
| Body Style: | Wagon | Year: | 2015 |

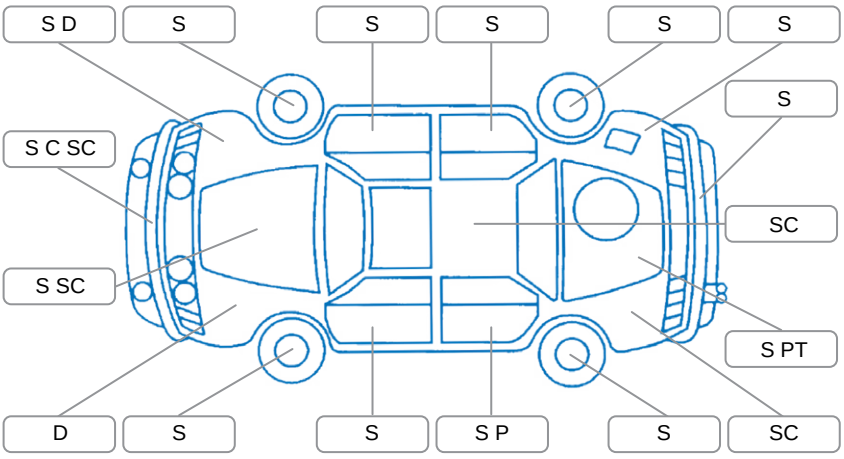
Note: some defects and blemishes may not be displayed in the diagram

Stone chips in the windscreen,
