# Turners

## Basic Condition Guide

| Make: | Subaru | Model: | Impreza |
| Body Style: | Hatchback | Year: | 2012 |

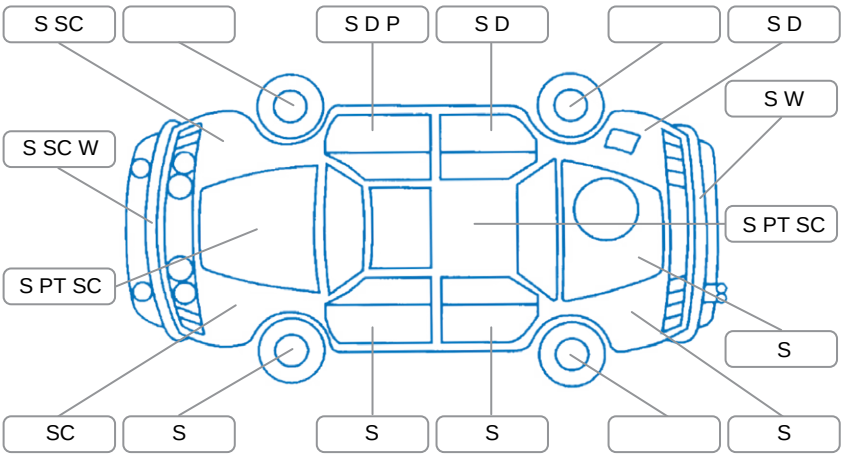
Note: some defects and blemishes may not be displayed in the diagram

Plastic surround trim on right side wing mirror is cracked & broken. Side walls on both front tyres are starting to perish. Starting to develop rust around right side of rear tailgate frame, on C pillar & up by right side tailgate hinge.
