# Turners

## Basic Condition Guide

| Make: | Mazda | Model: | CX-5 |
| Body Style: | SUV | Year: | 2013 |

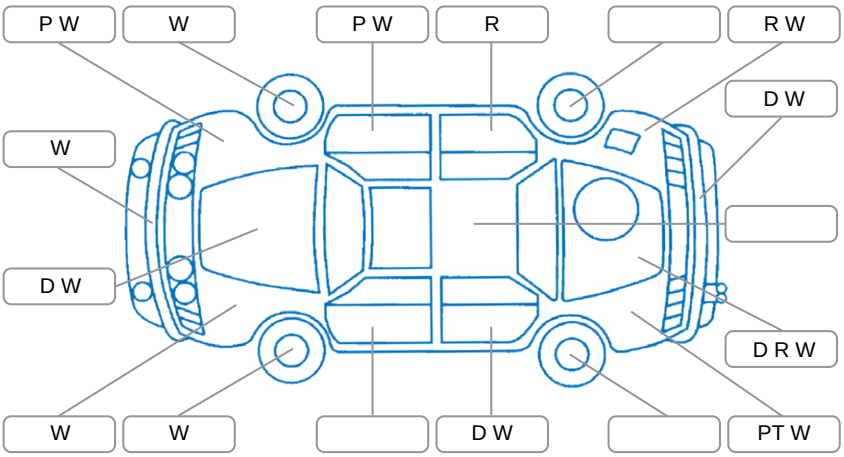
Note: some defects and blemishes may not be displayed in the diagram

Rear bumper misaligned
Left mirror cover missing
