Basic Condition Guide

Report ID:	27,987,605	Version:	2
Created:	20 Feb 2026

Make:	Honda	Model:	CRV
Body Style:	Hatchback	Year:	2007
Rego No.:	LAS233	Rego Expiry:	06 Jul 2026
WoF Expiry:	27 Jan 2027	Odometer:	172,157 Kms
Good No.:	27987605	VIN:	7AT08G7HX17005568
Next Service:	171,500 Kms	Service History:	No

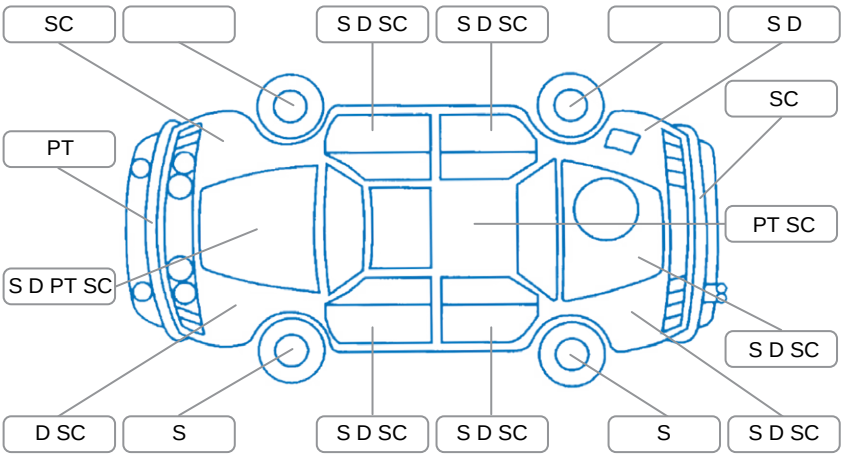
LF guard trim loose.
LH mirror surround cracked.
Aerial missing.
Crack in windscreen.
Water in spare wheel well.
