Turners

Basic Condition Guide

Report ID:	28,011,636	Version:	2
Created:	27 Feb 2026

Make:	Suzuki	Model:	Swift
Body Style:	Hatchback	Year:	2017
Rego No.:	NCQ104	Rego Expiry:	02 Nov 2025
WoF Expiry:	31 Jul 2025	Odometer:	161,472 Kms
Good No.:	28011636	VIN:	7AT0GK0CX20110867
Next Service:	123859	Service History:	No

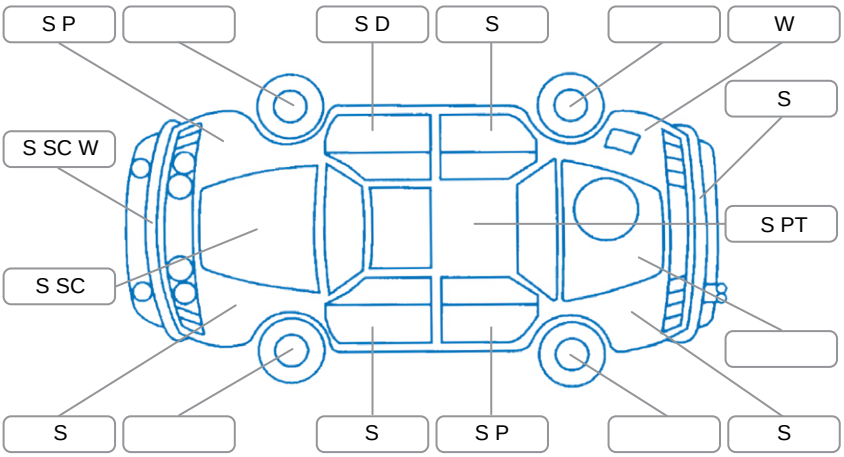
Note: some defects and blemishes may not be displayed in the diagram
