Turners

Basic Condition Guide

Report ID:	28,022,399	Version:	2
Created:	05 Mar 2026

Make:	Nissan	Model:	Terrano
Body Style:	Wagon	Year:	1997
Rego No.:	HMC921	Rego Expiry:	01 May 2026
WoF Expiry:	11 Aug 2026	Odometer:	229,280 Kms
Good No.:	28022399	VIN:	7A8DH2B0706008367
Next Service:	233,000 Kms	Service History:	No

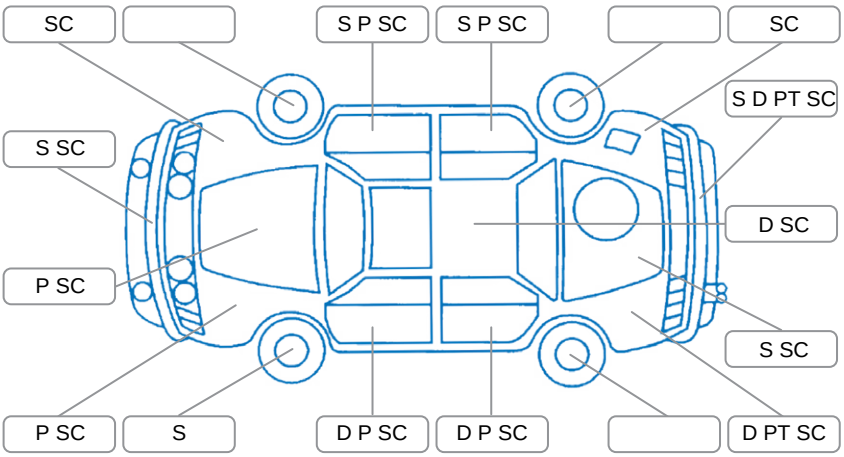
Note: some defects and blemishes may not be displayed in the diagram

Both taillights fit poorly.
LF door window monsoon damaged.
LF guard mirror cover missing.
Drivers door seal torn.
RH side mirror loose.
Rust on sunroof frame.
