Turners

Basic Condition Guide

Report ID:	28,180,825	Version:	1
Created:	19 Jun 2026

Make:	Mitsubishi	Model:	Outlander
Body Style:	Wagon	Year:	2008
Rego No.:	MTH676	Rego Expiry:	11 May 2026
WoF Expiry:	17 Mar 2027	Odometer:	195,265 Kms
Good No.:	28180825	VIN:	7AT0CJ3MX20205053
Next Service:	202,000km's	Service History:	No

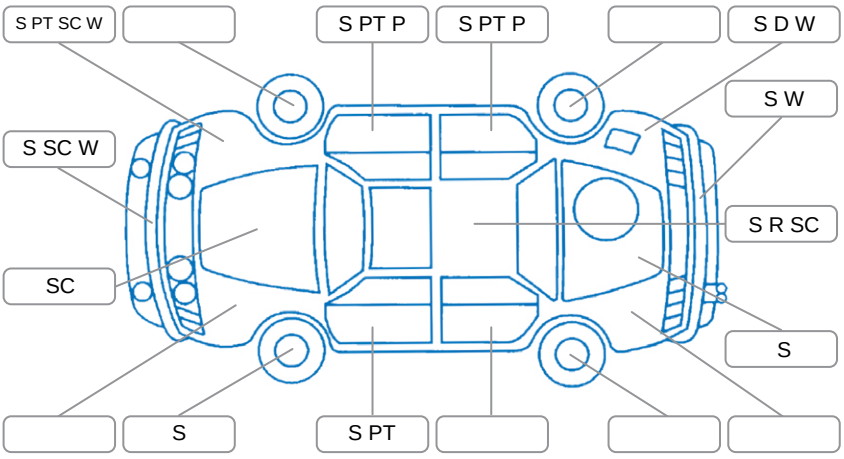
Right side of front bumper & right bottom moulding are not fitting properly. Right front spot light surround is missing. Right front inner guard panel is cracked & broken, has bottom part missing. Plastic cover missing off left rear roof rack bracket.
