# Turners — Basic Condition Guide

| Make: | Suzuki | Model: | Swift |
| Body Style: | Hatchback | Year: | 2013 |
| Rego No.: | NFW686 | Rego Expiry: | 30 Jun 2027 |

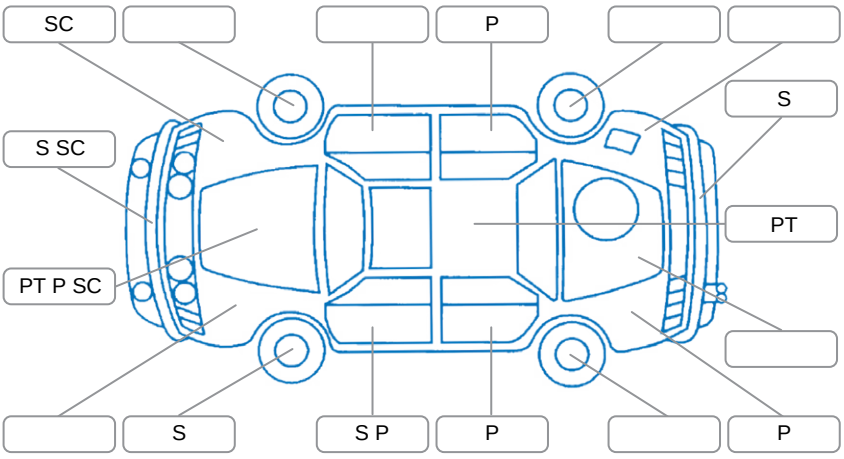
Chipped windscreen.
Lower grille chipped on corner.
