# Turners

## Basic Condition Guide

| Report ID: | 28,447,146 | Version: | 4 |

| Make: | Ford | Model: | Ranger |

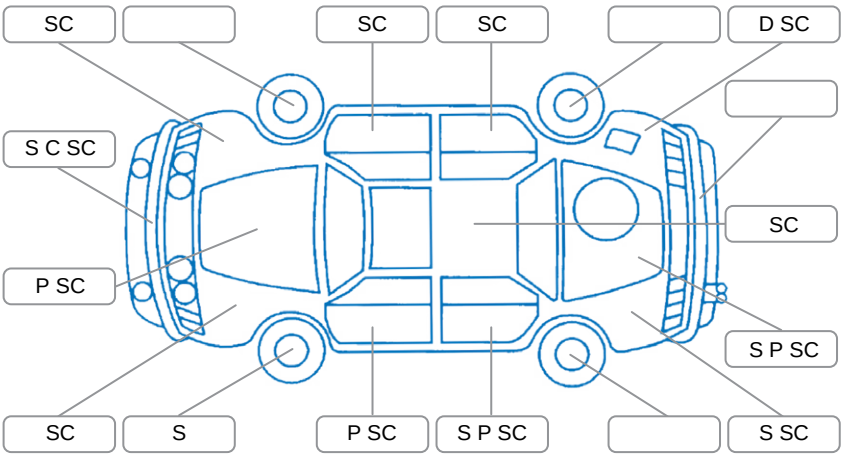
Rear bumper pushed in on LH side.
Dent in RR step plate.
RF step plate worn.
Stone chip in windscreen
LH running board damaged.
Front bumper needs refitted.
