# Turners

## Basic Condition Guide

| Make: | Honda | Model: | FIT |
| Body Style: | Hatchback | Year: | 2006 |

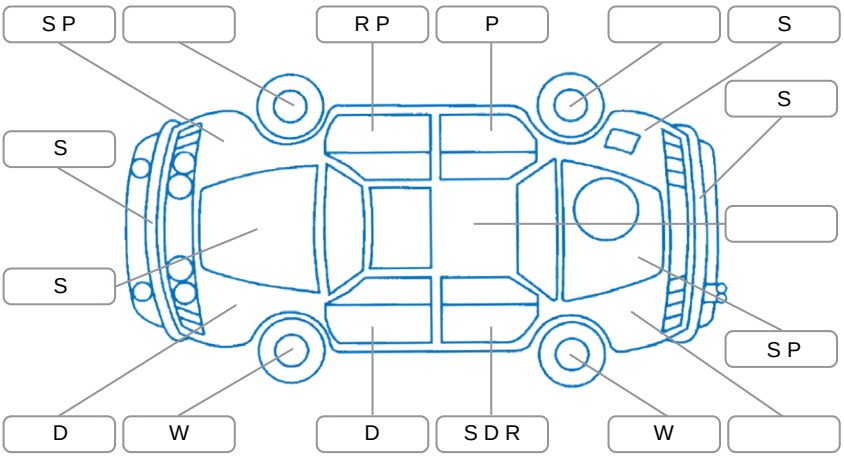
Headlights faded
RF tie rod ball joint leaking
Tailgate interior seal torn
Tailgate logo needs refit

R cant rail paint defect
