# Turners

## Basic Condition Guide

| Make: | Nissan | Model: | Navara |
| Body Style: | Utility | Year: | 2019 |

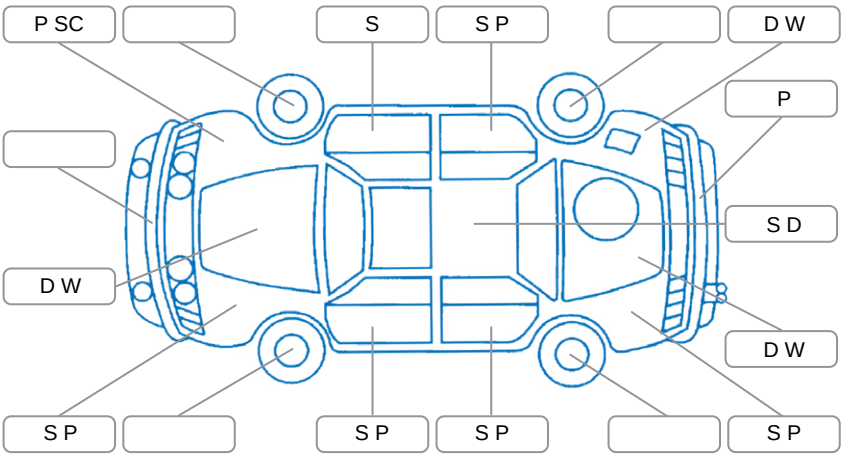
Right C pillar pin dented
Left running board scuffed
Windscreen stone chip not in CVA
