## Basic Condition Guide

| Make: | Volkswagen | Model: | Polo |
| Body Style: | Hatchback | Year: | 2008 |
| Rego No.: | NFE27 | Rego Expiry: | 01 Nov 2026 |

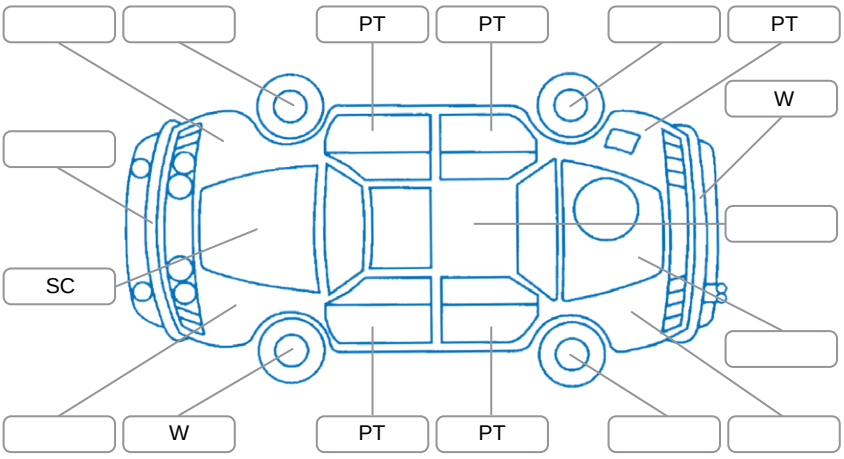
S = Scratch R = Rust C = Crack * = Decals W = Significant scuffs
D = Dent PT = Paint defect P = Pin dent SC = Stone Chips

Note: some defects and blemishes may not be displayed in the diagram

| Conditions During Body Inspection | Wet |
