# Turners — Basic Condition Guide

| Make: | Subaru | Model: | BRZ |
| Body Style: | Sports Car | Year: | 2013 |

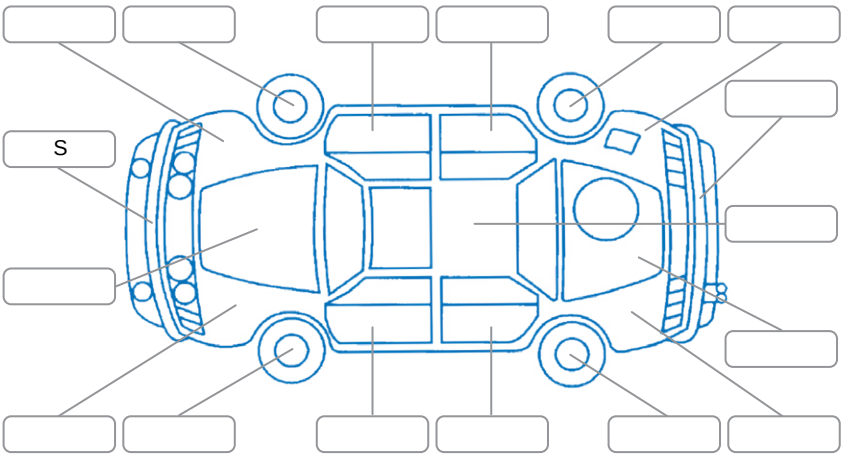
S = Scratch R = Rust C = Crack * = Decals W = Significant scuffs
D = Dent PT = Paint defect P = Pin dent SC = Stone Chips

Note: some defects and blemishes may not be displayed in the diagram

Spare wheel missing
All four wheels have snow tyres and below 4.0mm tread depth
