# Turners

## Basic Condition Guide

| Make: | Ford | Model: | Endura |
| Body Style: | SUV | Year: | 2019 |

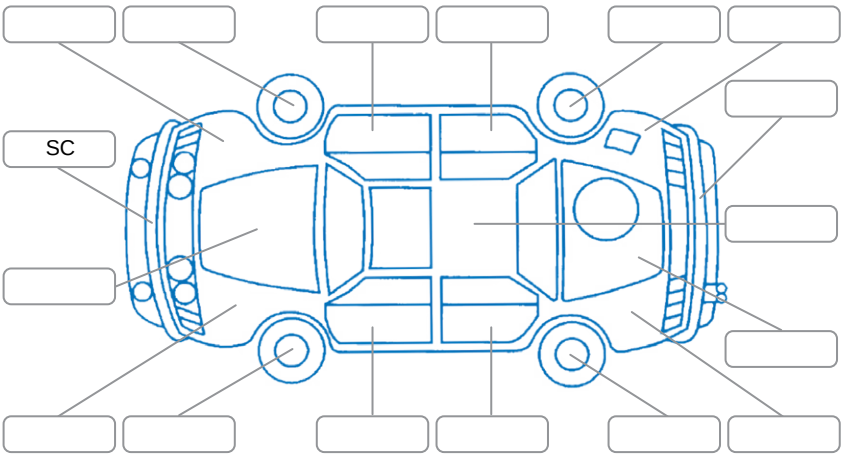
S = Scratch R = Rust C = Crack * = Decals W = Significant scuffs
D = Dent PT = Paint defect P = Pin dent SC = Stone Chips

Note: some defects and blemishes may not be displayed in the diagram

| Conditions During Body Inspection | Dry |
