# Turners

## Basic Condition Guide

| Make: | Mitsubishi | Model: | Outlander |
| Body Style: | SUV | Year: | 2020 |

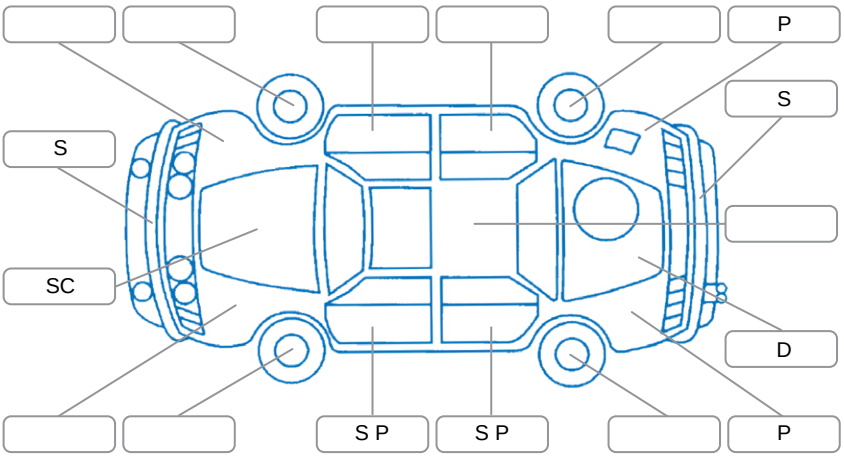
Pitting in windscreen.
