# Turners

## Basic Condition Guide

| Make: | KIA | Model: | Seltos |
| Body Style: | SUV | Year: | 2022 |

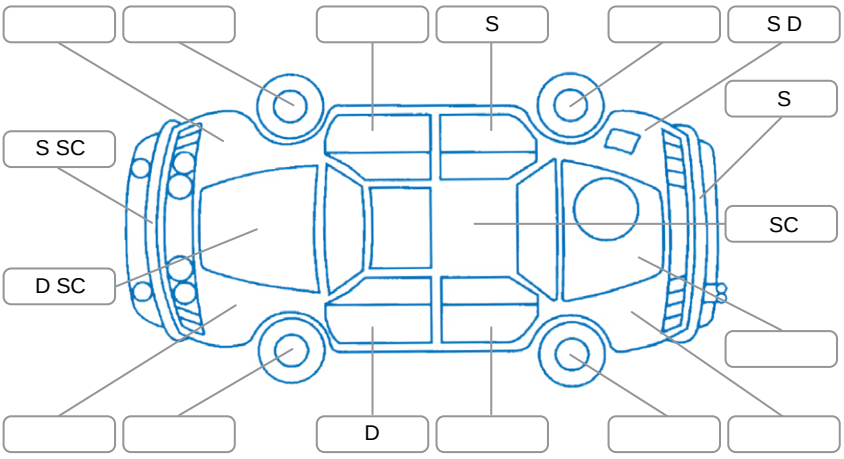
Left front tyre outer edge worn
Stone chips on front windscreen

Front wheel drive
Fuel tank pump under protection cover damaged
