# Turners

## Basic Condition Guide

| Report ID: | 29,088,715 | Version: | 1 |

| Make: | Mitsubishi | Model: | Triton |

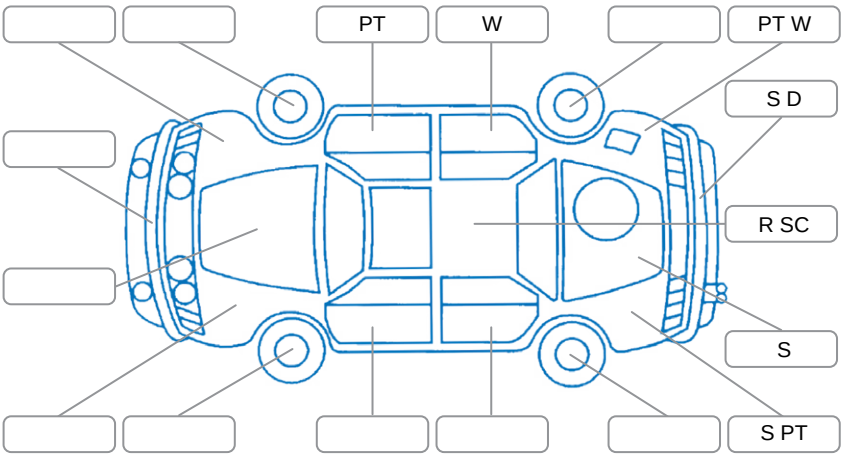
S = Scratch R = Rust C = Crack * = Decals W = Significant scuffs
D = Dent PT = Paint defect P = Pin dent SC = Stone Chips

Note: some defects and blemishes may not be displayed in the diagram
