Basic Vehicle Condition Guide

Make: Model: Suzuki Swift **Body Style:** Hatchback Year: 2,014 Registration: Reg Expiry: **HMJ606** 10 Dec 2018 **Odometer:** WoF Expiry: 20 Sep 2018 **Good No:** 18558949 60,471 Kms VIN: **Next Service: Service History:** JSAFZC82S00305601 72000

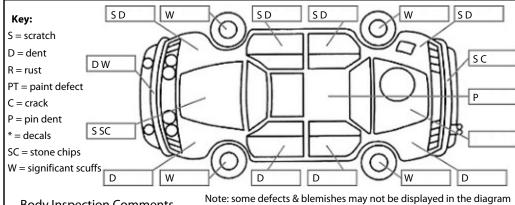
Body Inspection Comments

Left hand taillight cracked Rear bumper not fitted correctly Windscreen chips
