Created: 21 Mar 2018

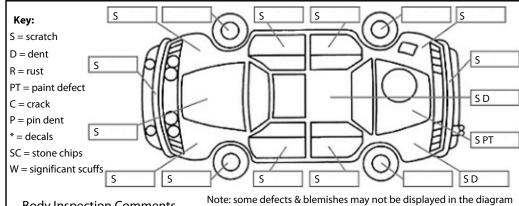
Body Inspection Comments

Stone chip on front windscreen

Window washer and wiper blade needs attention

L/F tyre needs replacing(outter wear)
