Make:	Suzuki	Model:	Grand Vitara	Body Style:	SUV
Year:	2009	Registration:	EZK147	Reg Expiry:	20 Aug 2020
WoF Expiry:	08 Jun 2020	Odometer:	250,107 Kms	Good No:	17657662
VIN:	JSAJTAA4V00102628	Next Service:	258890	Service History:	No

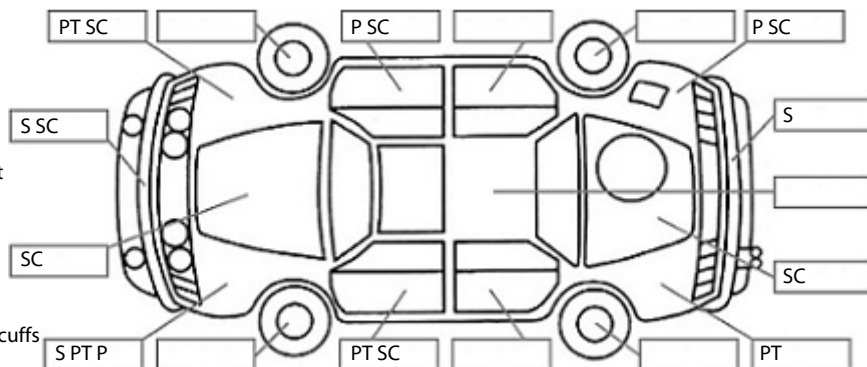
Body Inspection Comments

Note: some defects & blemishes may not be displayed in the diagram

Poor paint touchup on LF guard. Paint coming off LH door and LR guard trim. Spare wheel cover worn. Screen on stereo not working properly. Screw holes in console and dash. Blanking plate missing in console. Rear seat removed but seatbelts are fitted. Parcel tray missing. RF seat is worn.
