| Make: | Mitsubishi | Model: | Airtrek | Body Style: | SUV |
| Year: | 2003 | Registration: | DJN102 | Reg Expiry: | 06 Sep 2019 |

Body Inspection Comments

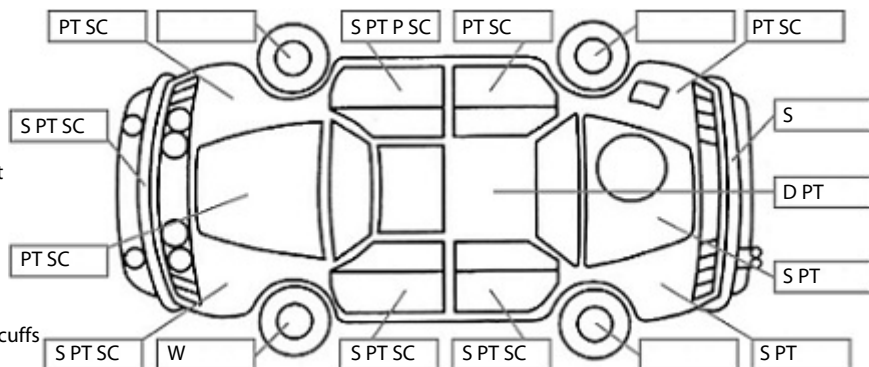
S = scratch
D = dent
R = rust
PT = paint defect
C = crack
P = pin dent
* = decals
SC = stone chips
W = significant scuffs

Note: some defects & blemishes may not be displayed in the diagram

Clearcoat is coming off vehicle. Bad fading on vehicle. Damage on RH mirror. Stonechips on windscreen. RH taillight cracked.
No wheel brace. Wear on RF seat.
