Make:	Nissan	Model:	Lafesta	Body Style:	SUV
Year:	2005	Registration:	GSR752	Reg Expiry:	13 Jul 2019
WoF Expiry:	18 Jul 2019	Odometer:	169,750 Kms	Good No:	17799045
VIN:	7AT0DH7DX1301122E	Next Service:	?	Service History:	No

Body Inspection Comments

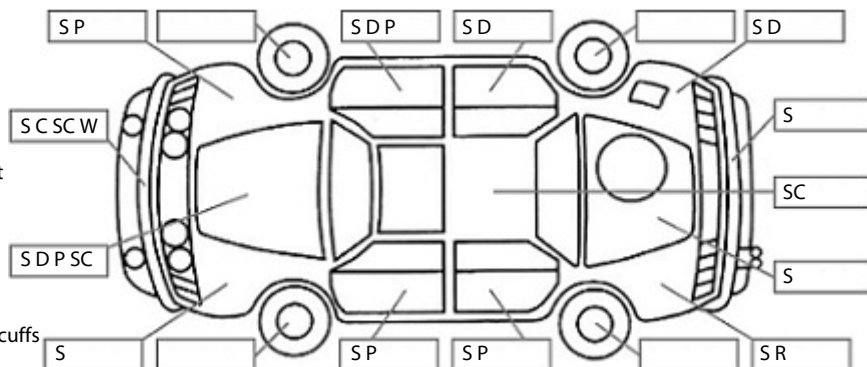
- Small stone crack in drivers viewing area of screen, would need repaired to pass a w.o.f.
- Stone chips in windscreen.
- Crack in middle of front bumper.
- Clip broken on left side of front bumper.
