<b>Make:</b>	Hyundai	<b>Model:</b>	H1	<b>Body Style:</b>	Van
<b>Year:</b>	2,009	<b>Registration:</b>	EZD896	<b>Reg Expiry:</b>	28 Jan 2019
<b>WoF Expiry:</b>	10 Aug 2018	<b>Odometer:</b>	160,050 Kms	<b>Good No:</b>	18091312
<b>VIN:</b>	KMFWBH7JR9U12375	<b>Next Service:</b>	166000	<b>Service History:</b>	No

## Body Inspection Comments

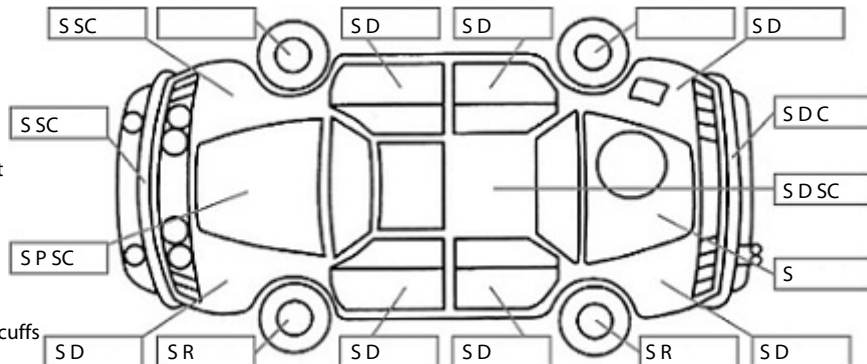
LR door latch broken not shutting ,rear bull bar dented,RR tail light broken,

Note: some defects & blemishes may not be displayed in the diagram
