| Make: | Toyota | Model: | Estima | Body Style: | People Mover |
| Year: | 2,006 | Registration: | KHG156 | Reg Expiry: | 08 Mar 2018 |

Body Inspection Comments

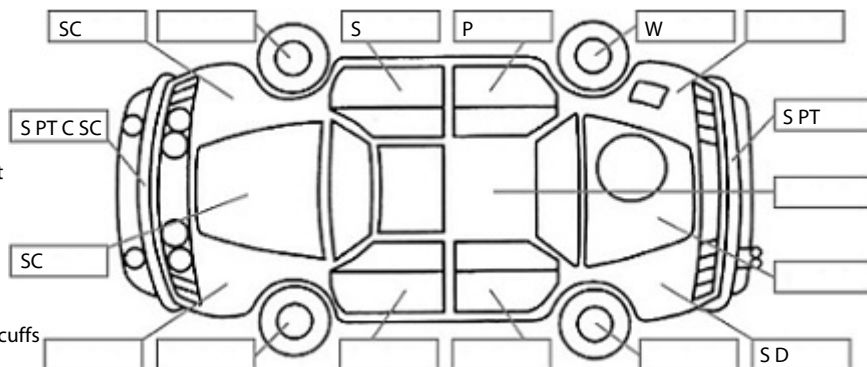
Note: some defects & blemishes may not be displayed in the diagram

RH spotlight is damaged and loose in front bumper. Stonechips on windscreen. Damage on front bumper. Headlamps need buffing. Ashtray missing in console. Tray on RHS of dash is damaged. Wear on RF door card. Remote locking not working.
