| Make: | Toyota | Model: | Ipsium | Body Style: | Wagon |
| Year: | 1,997 | Registration: | DDW392 | Reg Expiry: | 31 Aug 2018 |

Body Inspection Comments

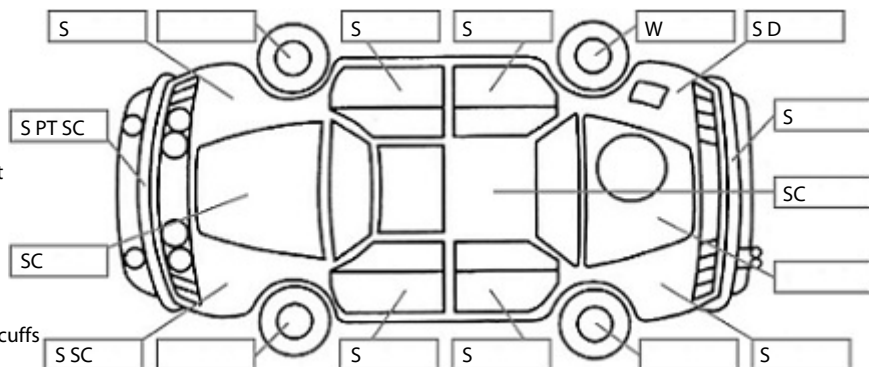
Moisture in RR indicator. Stonechips on windscreen.

RF seat and seatbelt are worn. Cloth coming off all door cards. Steering wheel has wear. Remote locking not working.
