| Make: | Toyota | Model: | Corolla | Body Style: | Hatchback |
| Year: | 2001 | Registration: | FTL925 | Reg Expiry: | 06 Nov 2018 |

Body Inspection Comments

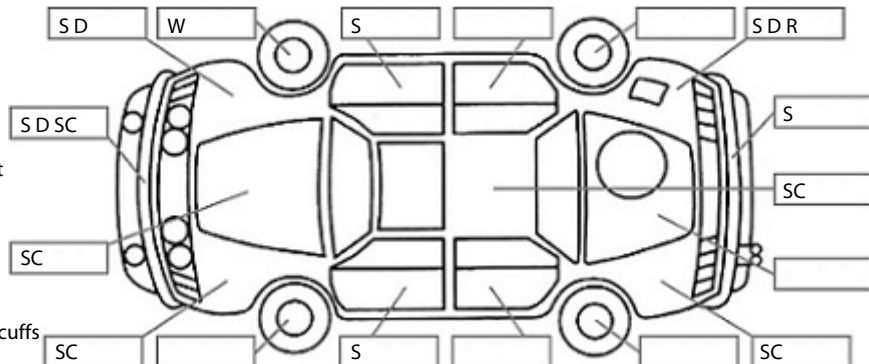
S = scratch
D = dent
R = rust
PT = paint defect
C = crack
P = pin dent
* = decals
SC = stone chips
W = significant scuffs

Note: some defects & blemishes may not be displayed in the diagram

Hubcaps missing LHS. Damage on RR guard. Stonechips on windscreen. Headlamps need buffing. Aerial damaged. Steering wheel worn. Console lid hinge damaged. AC not cold. Screen on stereo not working. RF seatbelt sometimes difficult to extend.
