Report ID: 18,600,390

Make:	Mazda	Model:	Bounty	Body Style:	Utility
Year:	2006	Registration:	DHB551	Reg Expiry:	20 Oct 2019
WoF Expiry:	08 Jun 2019	Odometer:	289,391 Kms	Good No:	18600390
VIN:	MM0UNY0W2004196	Next Service:	300000	Service Histor	'y: No

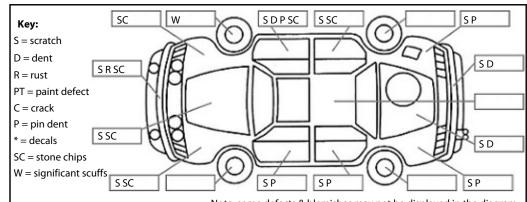
Note: some defects & blemishes may not be displayed in the diagram

Stonechips on windscreen, may need replacing. RH taillight lens has damage. RF indicator lens has hole and dirt inside. Bonnet trim is missing. Both front mudflaps damaged.

Screw holes in dash. Scratches on glovebox. LF central and remote locking not working. LR door ashtray missing. Wheel brace missing.
