<b>Make:</b>	Subaru	<b>Model:</b>	Legacy	<b>Body Style:</b>	Wagon
<b>Year:</b>	2003	<b>Registration:</b>	DQB502	<b>Reg Expiry:</b>	11 May 2019
<b>WoF Expiry:</b>	07 Dec 2018	<b>Odometer:</b>	211,831 Kms	<b>Good No:</b>	18618844
<b>VIN:</b>	JF1BP9KK44G003344	<b>Next Service:</b>		<b>Service History:</b>	No

## Body Inspection Comments

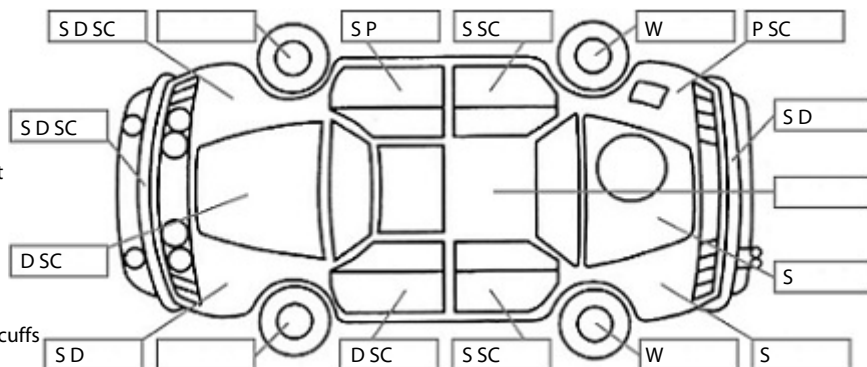
S = scratch  
D = dent  
R = rust  
PT = paint defect  
C = crack  
P = pin dent  
\* = decals  
SC = stone chips  
W = significant scuffs

Note: some defects & blemishes may not be displayed in the diagram

Scuffs on LH sill. LR door body rubber not fitting correctly. Paint coming off all wheels. Damage on RF guard. Clock has error. Mobile mount on console. Wires hanging below glovebox. Carper on cargo area damaged. RF seat has wear. Lens missing in RF door card.
