| Make: | Ford | Model: | Territory | Body Style: | SUV |
| Year: | 2005 | Registration: | CYF474 | Reg Expiry: | 11 Feb 2019 |

Body Inspection Comments

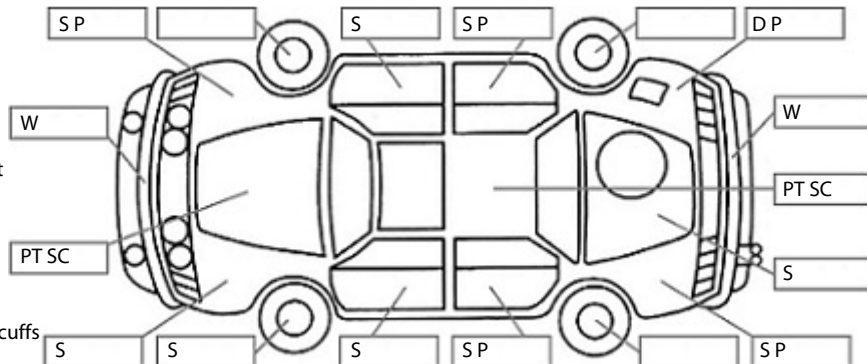
Note: some defects & blemishes may not be displayed in the diagram

Roof lining sagging, Dashboard tray lid not closing
Tailgate outer trim broken, insecure. Water inside LH tail lamp
All tyre worn out, FR tyre inner wear
FL power window not working
Mirror switch insecure
