| Make: | Mazda | Model: | B2500 | Body Style: | Utility |
| Year: | 1998 | Registration: | CCM474 | Reg Expiry: | 01 Feb 2019 |

Body Inspection Comments

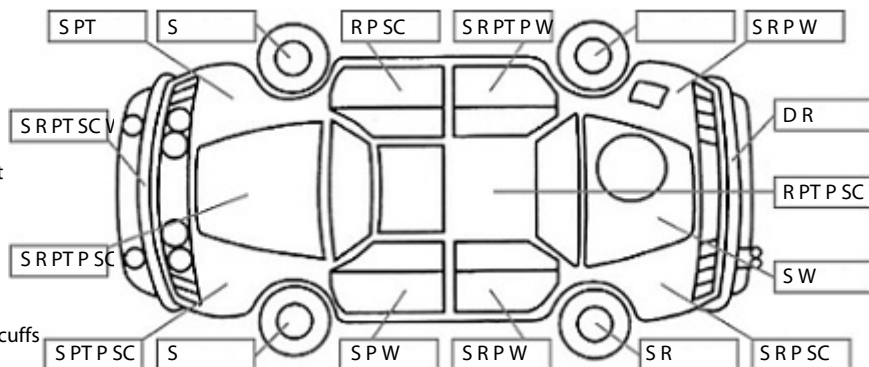
Paint fade left front quarter, bonnet, right front quarter, front bumper and roof, crack in left tail light, scratch marks on right tail light, damage around right canopy window, rust on both wiper blade arms,
