| <b>Make:</b> | Isuzu | <b>Model:</b> | Bighorn | <b>Body Style:</b> | Wagon |
| <b>Year:</b> | 1995 | <b>Registration:</b> | EUD121 | <b>Reg Expiry:</b> | 29 Jan 2019 |

**Body Inspection Comments**

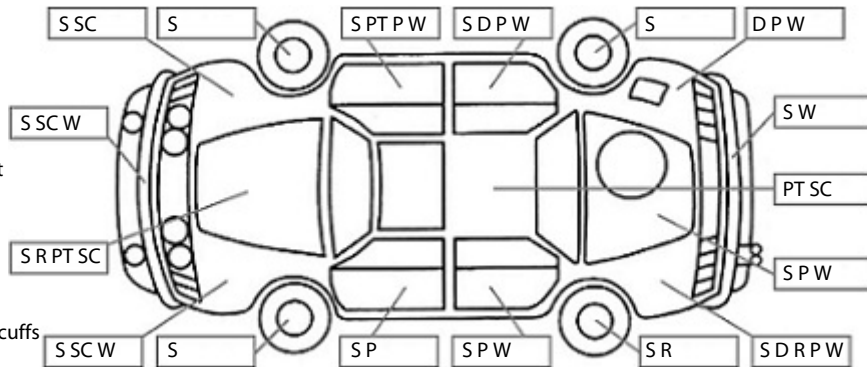
Note: some defects & blemishes may not be displayed in the diagram

Paint fade on bonnet, scuff marks left wing mirror, both tail lights has been glued back together, stone chips in the windscreen,
