| Make: | Toyota | Model: | Hiace | Body Style: | Van |
| Year: | 2007 | Registration: | DRM629 | Reg Expiry: | 09 Jan 2020 |

Body Inspection Comments

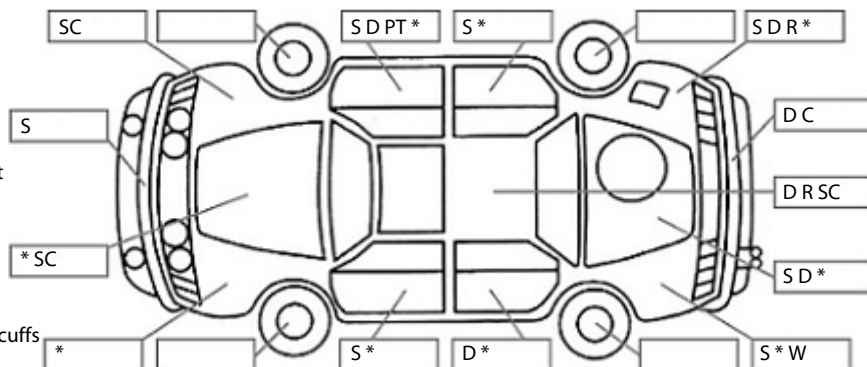
RH headlamp, FR door broken. RH mirror faded. RR door moulding insecure. Tail door moulding torn. Rear seat back shaking. Spare wheel inside. LH taillamp cracked. Rear badge missing
FR foot step trim insecure. Stone chip on front windscreen
Front tyres inner edge wear. LH mirror broken
