<b>Make:</b>	Holden	<b>Model:</b>	Rodeo 4X2	<b>Body Style:</b>	Utility
<b>Year:</b>	2005	<b>Registration:</b>	CYD637	<b>Reg Expiry:</b>	19 Feb 2020
<b>WoF Expiry:</b>	22 May 2019	<b>Odometer:</b>	282,580 Kms	<b>Good No:</b>	19149919
<b>VIN:</b>	MPATFR77H5H58463	<b>Next Service:</b>		<b>Service History:</b>	No

## Note: This report is not a warranty

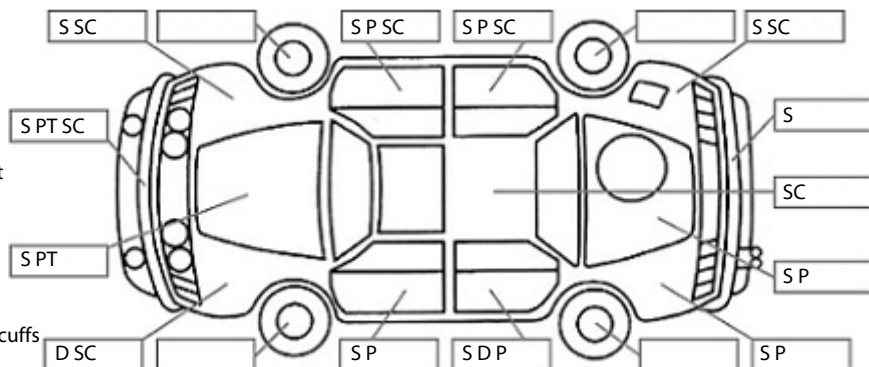
RH number plate lamp not going. Both spotlamps not going. Sports bar in tray is not secure. Stonechips on windscreen. Bonnet has been sanded back to primer. Front bumper has been repainted badly. Extra switches in dash. Switch blank missing. Lower section of RH dash not fitting correctly.
