<b>Make:</b>	Daihatsu	<b>Model:</b>	Storia	<b>Body Style:</b>	Hatchback
<b>Year:</b>	2000	<b>Registration:</b>	EBS830	<b>Reg Expiry:</b>	23 May 2019
<b>WoF Expiry:</b>	14 Aug 2019	<b>Odometer:</b>	188,632 Kms	<b>Good No:</b>	19164893
<b>VIN:</b>	7A847230707000405	<b>Next Service:</b>		<b>Service History:</b>	No

## Note: This report is not a warranty

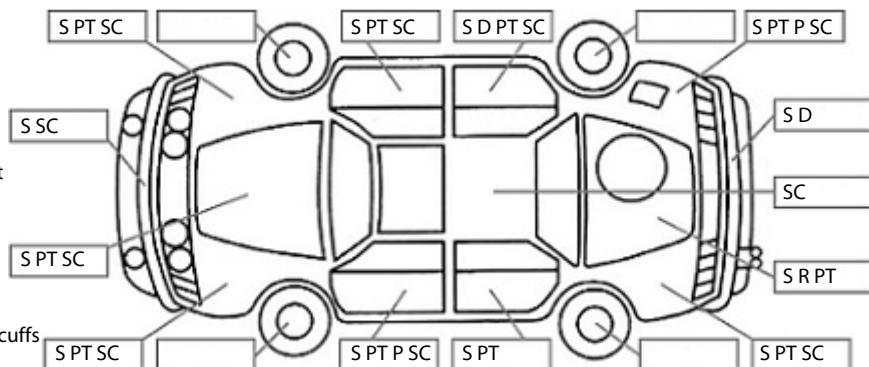
RF window switch damage, cannot check RF window operation. Suntan lotion damage on paint. LF door monsoon broken. Tailgate has primer paint. No jack handle. Boot board damaged. Rust marks inside tailgate. RR door lock knob missing. Stonechips on windscreen. All wheels rusty.
